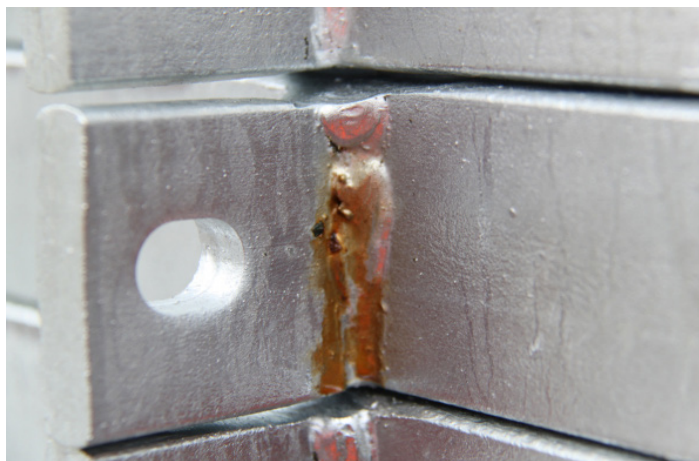
Staining and discolouration sometimes takes place at or adjacent to welds as a result of weld seepage (Fig 1.) This occurs as a result of pretreatment solutions used to clean the steel prior to hot dip galvanizing becoming trapped in weld pin holes. The heat of the galvanizing process drives off any moisture leaving behind a residue in the pin holes. However, when externally exposed, moisture is drawn into the pin holes by capillary action and the residue dissolves and then seeps out to give a reddish/brown discolouration. Such staining may be removed by wire brushing and provided all the residue has seeped out, staining should not reoccur.

Fig 1. Weld seepage staining

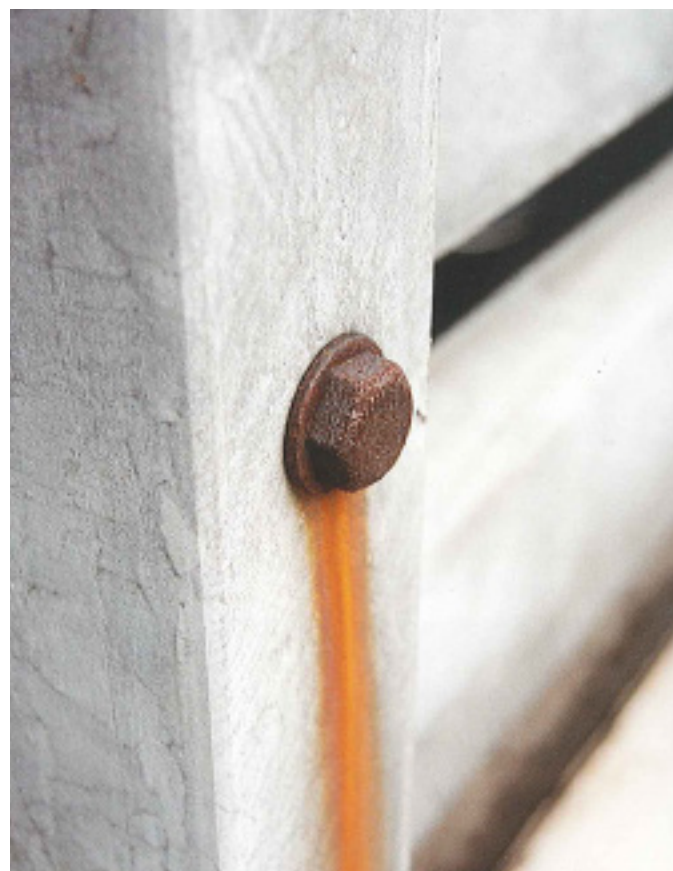
If water runs off uncoated steelwork it will contain a small amount of dissolved iron. If such water runs onto a galvanized surface and subsequently dries out, it leaves a reddish/brown stain (Fig 2.)

Fig 2. Corrosion of uncoated fastener resulting in rust staining of the galvanized surface

If galvanized steelwork is subject to mechanical damage, or it is welded with inadequate repair being conducted, then the exposed area may corrode leading to staining and discolouration of the surrounding sound galvanized coating. Rust staining may be removed by mild abrasion or cleaning with commercial grade oxalic acid, the latter process requiring subsequent washing down with fresh water, after which the steelwork should be allowed to fully dry out. It is essential though that any exposed surfaces are repaired so as to prevent possible future corrosion and staining.
